# DAC Test Train in Poland 2022

DAC4EU Frankfurt 30.11.2022

## DAC Test Train by the DAC4EU Consortium at PKP CARGO Tests in Poland:

Tests 10th -20th July 2022

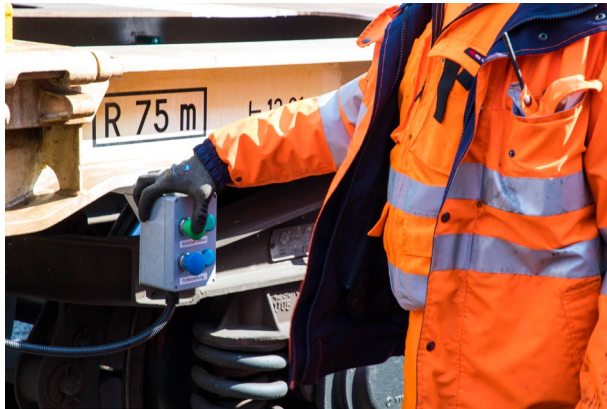
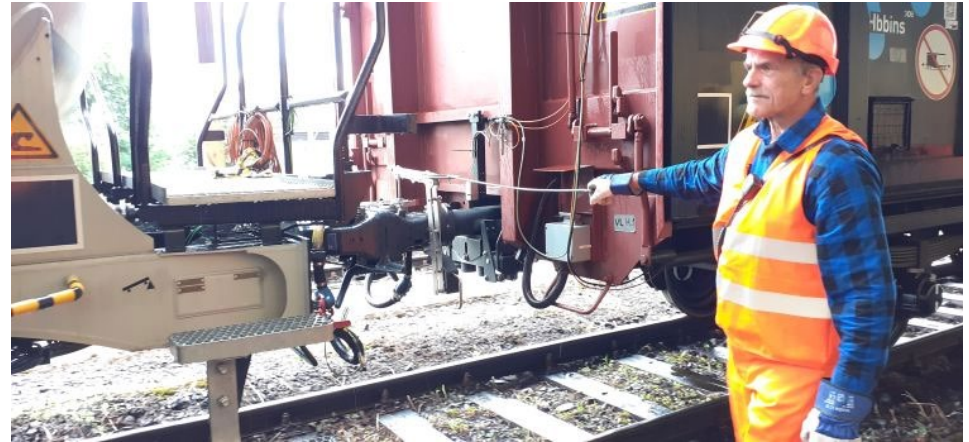
- Poznań Franowo
- Train shunting on the marshalling yard

- Depending on the design of the uncoupling mechanism, it was possible to decouple single wagons and groups of wagons on the hump during movement of the train and with buffer positions off.
  - For couplers with electric buttons decoupling on the hump could be done during train movement. Wagon disconnections at 3-5 km/h train speed and at predefined locations were tested.
  - For couplers with mechanical handle working vertically decoupling on the hump could be done at a slow speed (3-5 km/h) using an additional tool (hook). Wagon disconnections at predefined locations were tested.
  - During uncoupling of the moving wagons, the predefined locations did not have to be met exactly.

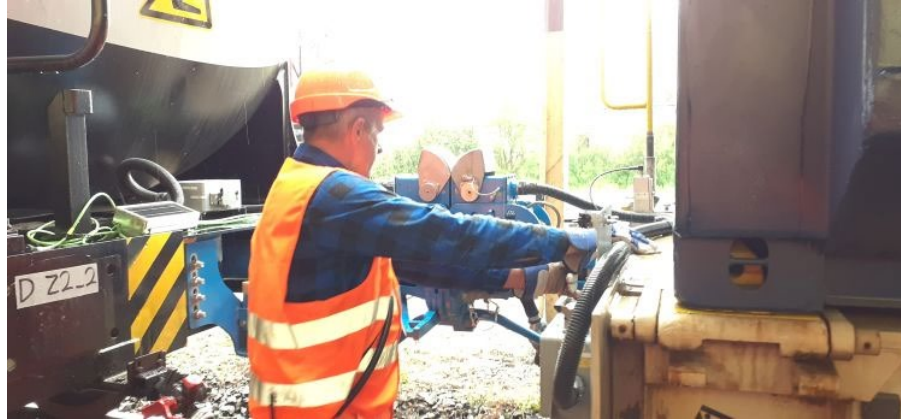
- **Poznań Franowo**
- **Train shunting on the marshalling yard**

- ❑ **For couplers with mechanical handle working horizontally, decoupling on the hump could be done at zero speed only and in an exactly defined position on the hump. Using a tool wasn't possible mainly due to: (1) more than 90 degrees handle movement and (2) direction of the handle pulling is the same like direction of the moving wagons.**

- **Although the exact disconnection points for the wagons (distance from the top of the hump) have been calculated in advance, in a few cases the wagons stopped on the top of the hump and had to be pushed by hand in order to start rolling.**

- **This method was the most difficult to carry out and it's not operational.**
- ❑ **Disconnection of wagons with an empty brake pipe was tested. Quite often during disconnections, one coupler remained in the coupled position (brake pipe is open). Testing with 5 bar in brake pipe was not possible due to the risk of the distributor valve reaction.**

- ❑ **Almost 100% successful coupling at the classification tracks (not included situations when buffer position handle changed on its own).**
- ❑ **Generally positive feedback from shunting personnel.**

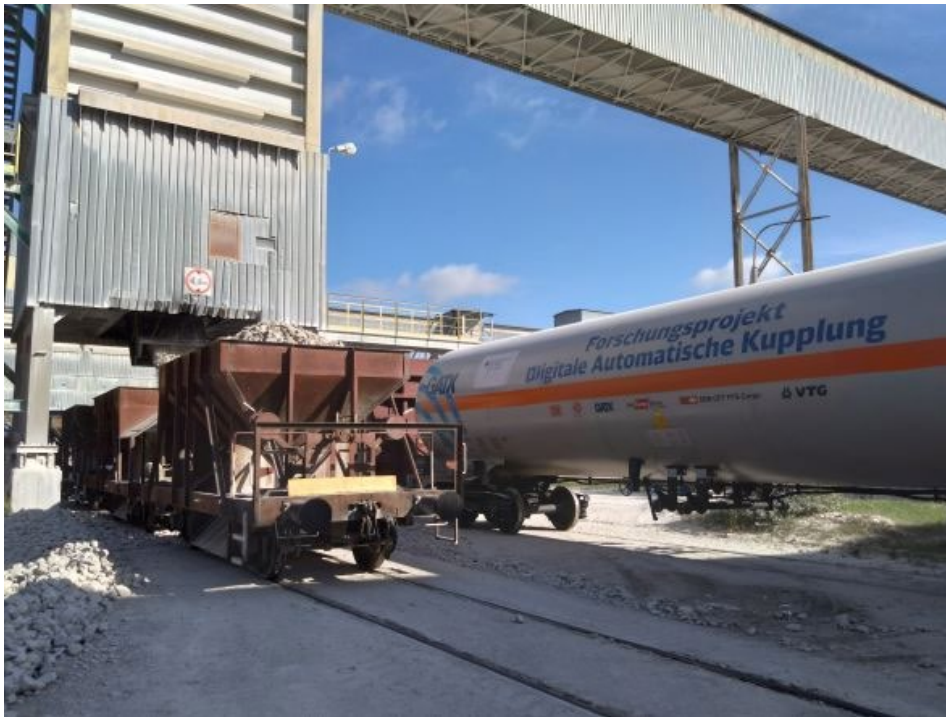
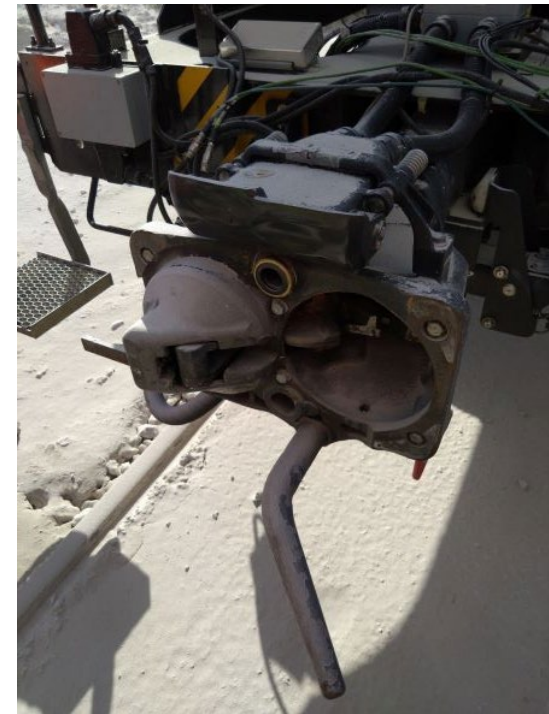
- **Cement Plant Lafarge near Inowrocław**
- **Exposure of the DACs part of the brake pipe to contamination generated during loading processes of bulk materials was investigated.**
- **Coupling tests on the curves were carried out (160 m- and S-curve).**

- **Wagons were standing in the siding for 18 hours, during this time, the loading of limestone and other building materials was carried out on the nearby tracks for about 4 hours.**

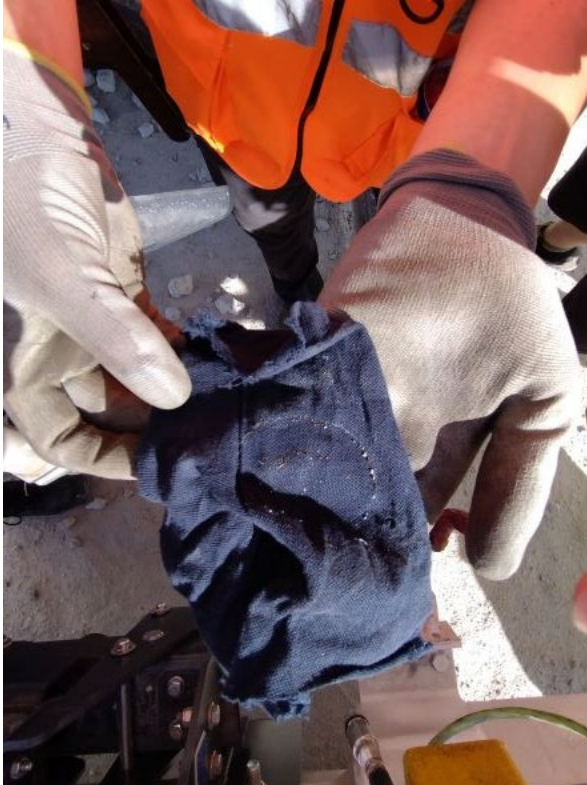
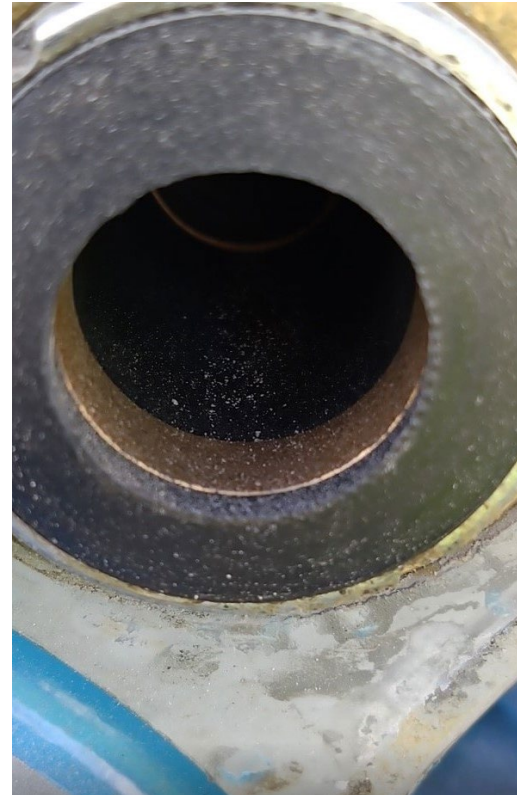
- **Cement plant Lafarge – Day II: Tests**

- ❑ **Visual checking of the contamination inside the open part of the brake pipe in the DAC-head showed that air was contaminated by dust and small particles of the lime stone material.**
- ❑ **The small particles of the lime stone material were caught by a piece of cotton cloth, which has been inserted between the air coupling heads. The amount of contaminants in the air raises serious doubts to the proper operation of the brake's pneumatic valves.**

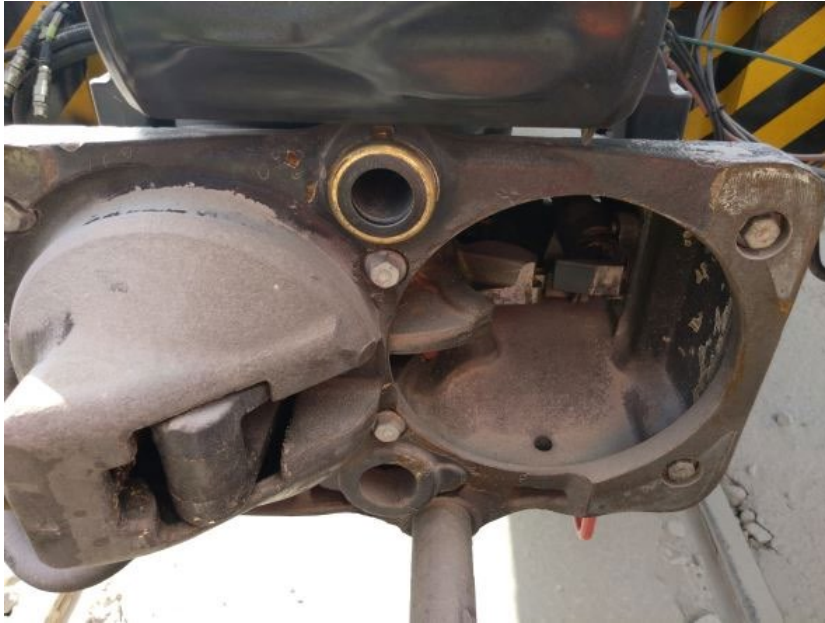
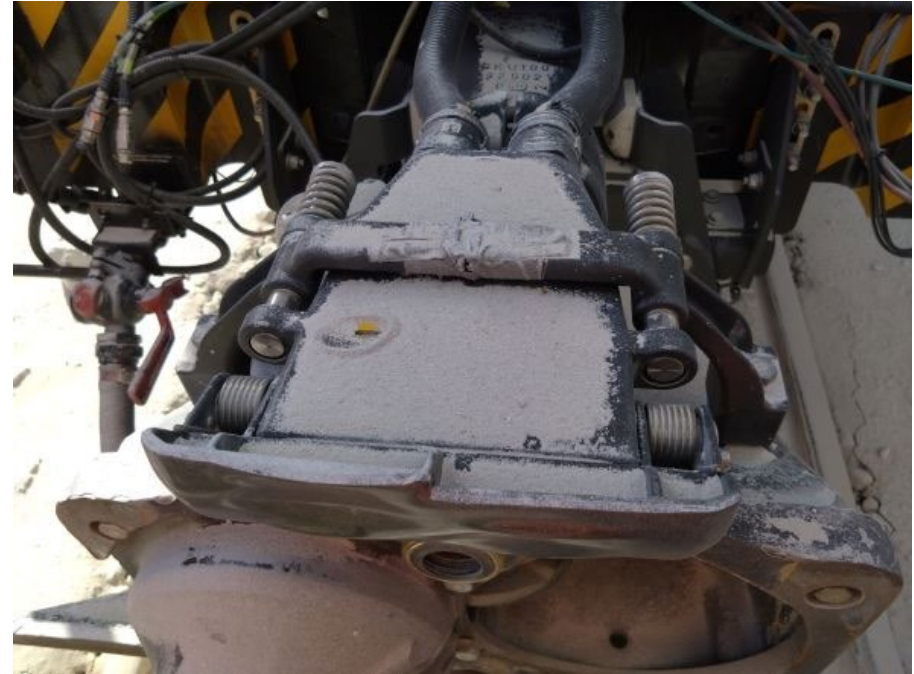
- **Cement plant Lafarge**

- ❑ **In the opinion of the siding operator, it is possible to speed-up the manoeuvring processes on one part of the siding (cement plant), on the second part of the siding (lime stone mining) improvement will not be high.**

**There may be a problem of contamination of the main brake pipe when loading / unloading loose bulk materials - further investigation needed**

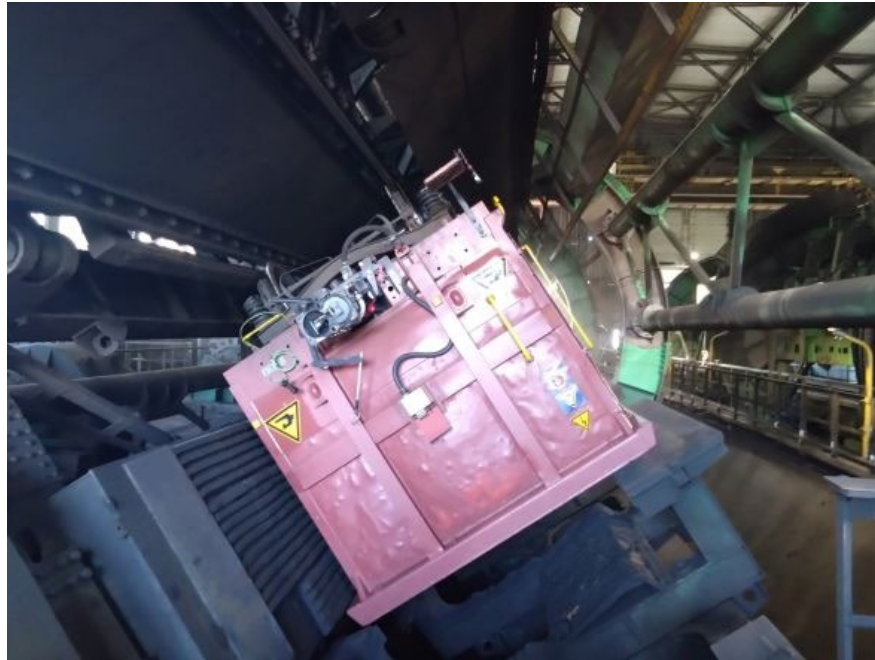
- **The process of placing wagons in a typical rotary coal unloading device and their pushing them out was investigated.**
- **Rotation of the wagon**

- ❑ **The process was possible thanks to the buffer position function, which is activated only on one coupler. Wagons were successful coupled after being pushed out. Tests were carried out with 0 bar in the brake pipe.**
- ❑ **The behaviour of the DAC during the rotation of the wagon on the rotary unloading device was checked. It was observed, that wagons intended for rotary unloading (series E) must have a slide mounted on top of the support, in order to protect the coupler-shaft.**

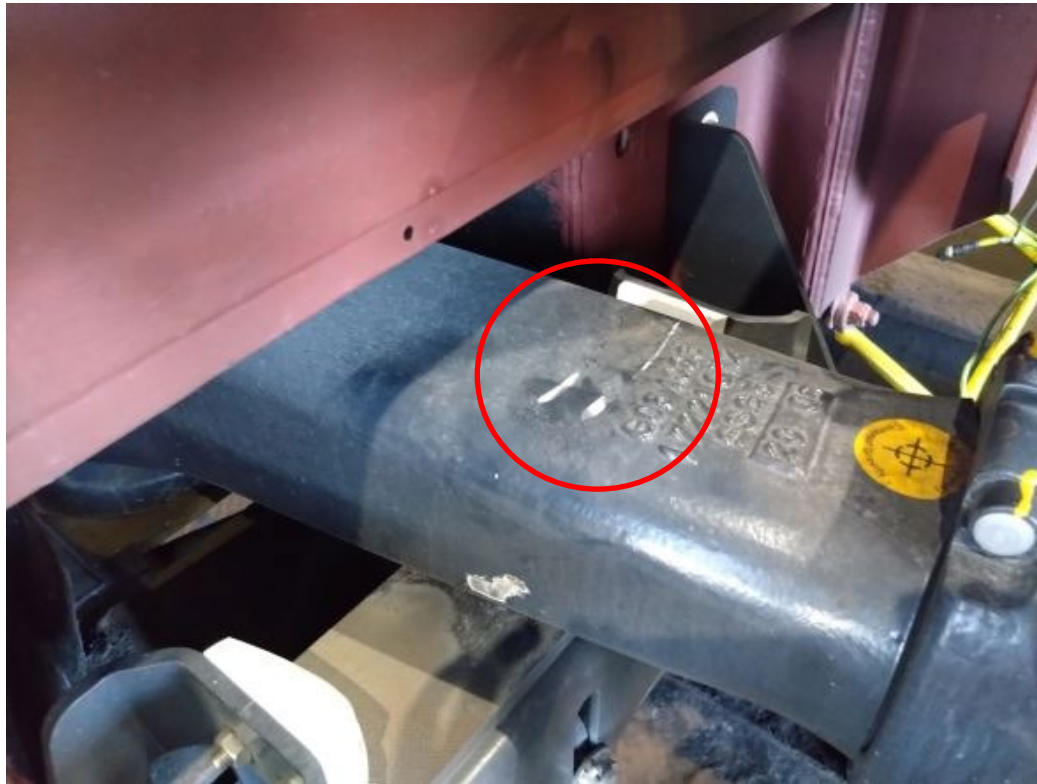
- **Coking plant Dabrowa Górnicza**

- **Doubts of local employees:**

- contamination of the brake pipe with coal dust generated during unloading.
- switching on/off buffer position not ergonomically.
- DAC resistance to high temperature during heating in the defrosting hall

- **Further tests needed on the contamination issue, resistance to high temperatures and unloading of the two coupled wagons**

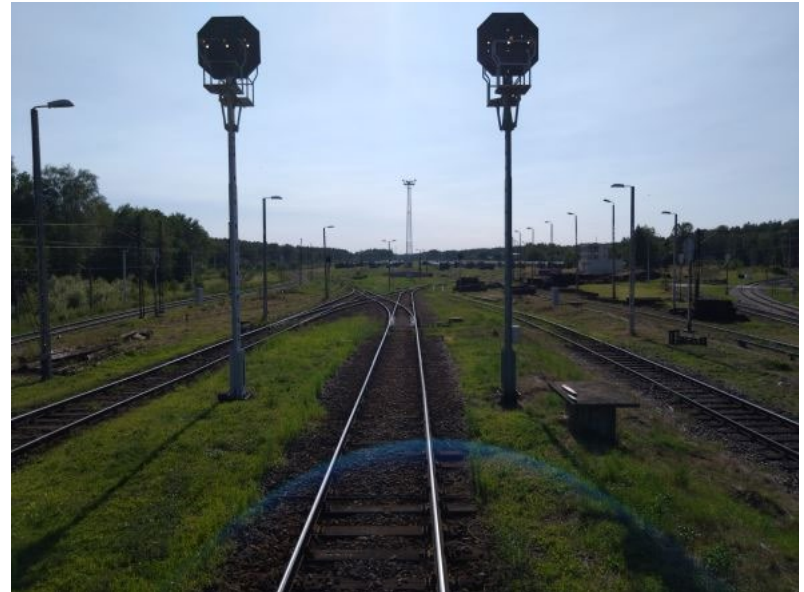
- **Marshalling yard Zabrzeg-Czarnolesie**
- **Train shunting on marshalling yard**
- **Wagons were braked by means of brake shoes (skids). (unreliable proces)**

- ❑ **The same method of decoupling the wagons on the hump was tested as in Poznań-Franowo station. Process was successful, no further conclusions.**
- ❑ **Due to the unreliable proces, wagons (both empty, loaded and mixed) were coupled at relatively high speeds (range 7,5 – 14 km/h). Recorded on some wagons forces weren't critically high. Draft gear/rubber spring preload forces of part of wagons were checked. The stroke indicators, where available, were also checked. No indication for a loss of preload force. The operation of the DAC in critical situations confirmed their durability and proper behaviour.**

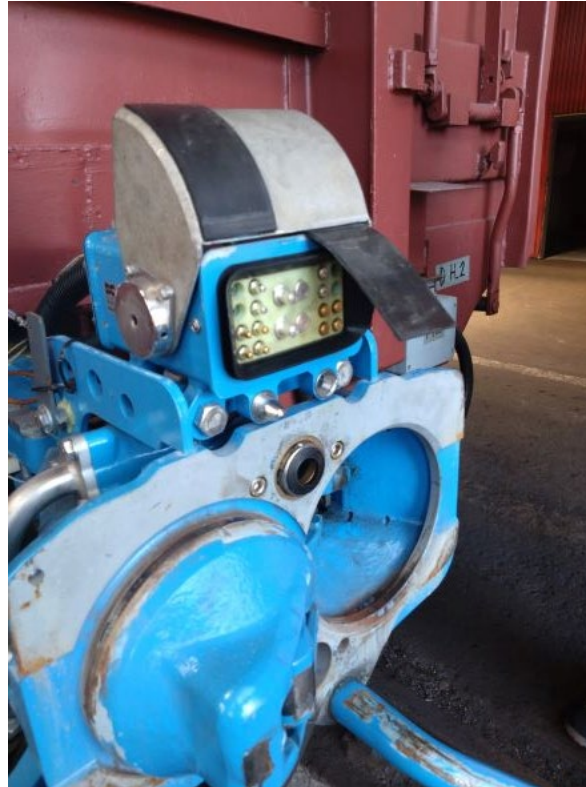
- **Marshalling yard Zabrzeg-Czarnolesie**
- **Train shunting on the marshalling yard**

- ❑ **One protect rubber on the electric coupler on the DAC was unglued and got stuck between electric coupler and its cover. Electric coupler remained open. Safety issue.**
- ❑ **One time a decoupling by means of electric button was failed. Reason wasn't know, the electric decoupler was active. First assumption was an empty battery. For shunting operations, especially from the hump, indicator lights of the battery status would be helpful.**
