Scope of this Presentation

DAC4EU | Conclusions from Operational Testing | Dr. Daniel Jobstfinke | 2022-11-30

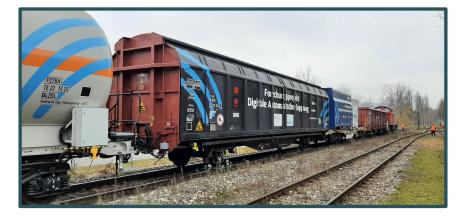
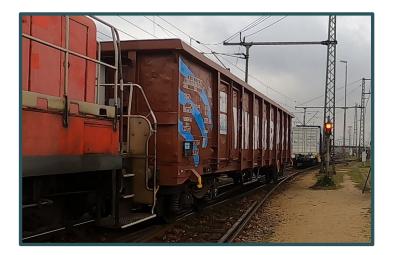
Locomotive pulling and pushing wagons from track to track

Fly shunting / push off operation:

Locomotive gives uncoupled wagon(s) a push and stops again, wagons continue to roll in designated track Main Issue 1 Incomplete Uncoupling

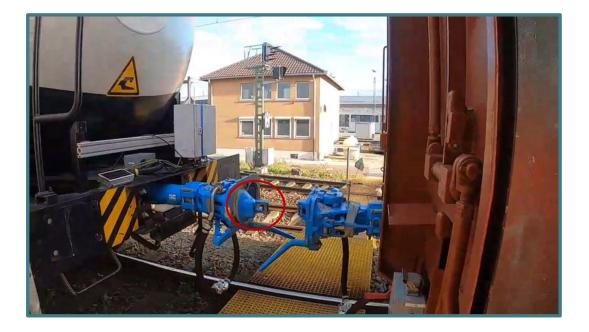
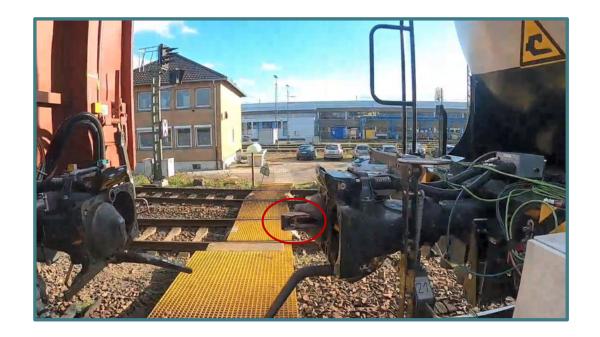
correct uncoupling

incomplete uncoupling

Incomplete uncoupling happens during ground level shunting as well as during hump operation

- Coupling in this condition is possible. However, wear and tear are increased
- This condition is not noticeable until the vehicles start to move and thus the DACs are separated → especially problematic for one person operation
- The pneumatic brake is usually used for ground level shunting → the brake pipe is filled
 - Incomplete uncoupling leads to abrupt discharging of the brake pipe and thus to loud noise
 - The brakes will immediately apply → if the DAC in coupled position is on the moving part of the train, it will stop again
- The gathering range of the DACs is decreased

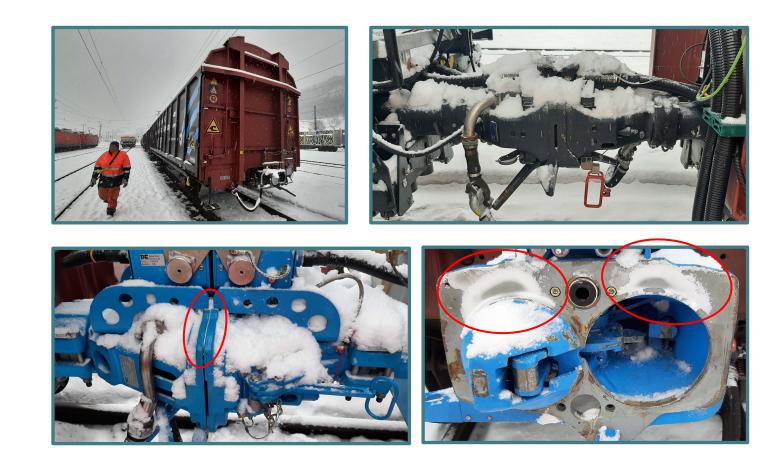
Tests in real-life winter conditions fully confirmed the Phase I climate chamber results

- Flat coupler front plates (like for passenger train couplers) compress snow to a thin layer of ice that prevents successful coupling
- Coupler front plates with a sufficient capability to push away snow and ice enable for reliable coupling in winter conditions
- A new finding was that the coupling state indicator became hard to see when the DACs are covered with snow

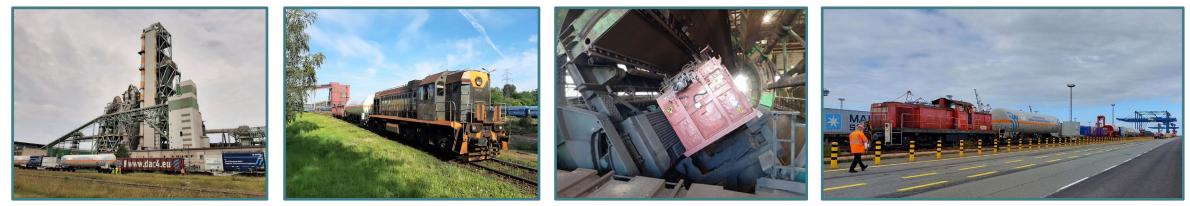
- Narrow curves (radius < 100 m) are not uncommon in these sites
 - The tests in real sites confirmed the Phase I tests results from the test facility:
 - wagons with DACs can run through such curves without any issues.
 - even uncoupling and uncoupling was possible down to radii of 45 m (for w agon type that is allow ed for such narrow curves)

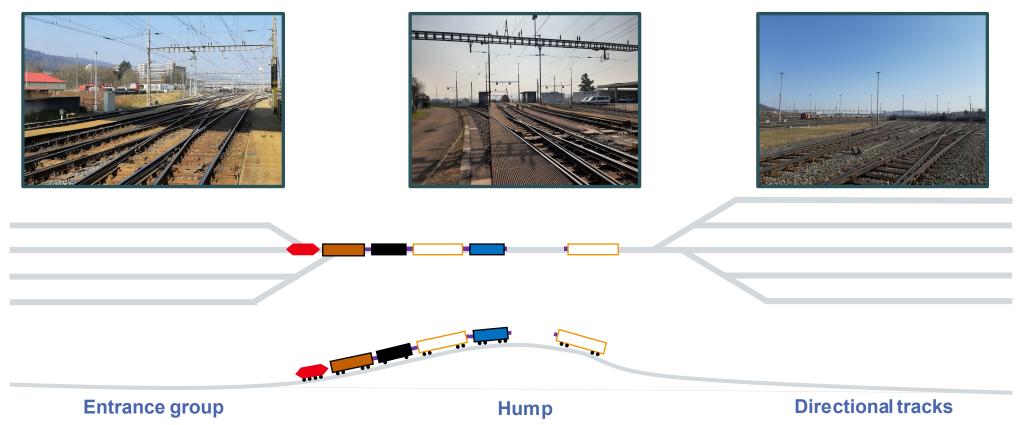
Depending on grade of automation, infrastructural design, national rules etc., uncoupling takes place either on hump or in entrance group

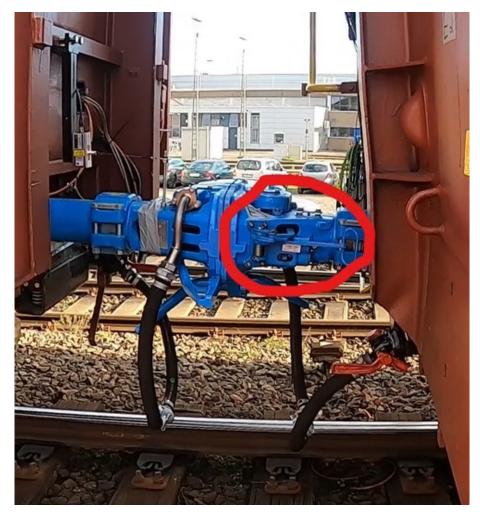
Short video of initially uncoupled DACs where the wagons are pushed towards the top of a hump.

The DACs couple unintendedly during the continuous movement of the wagons.

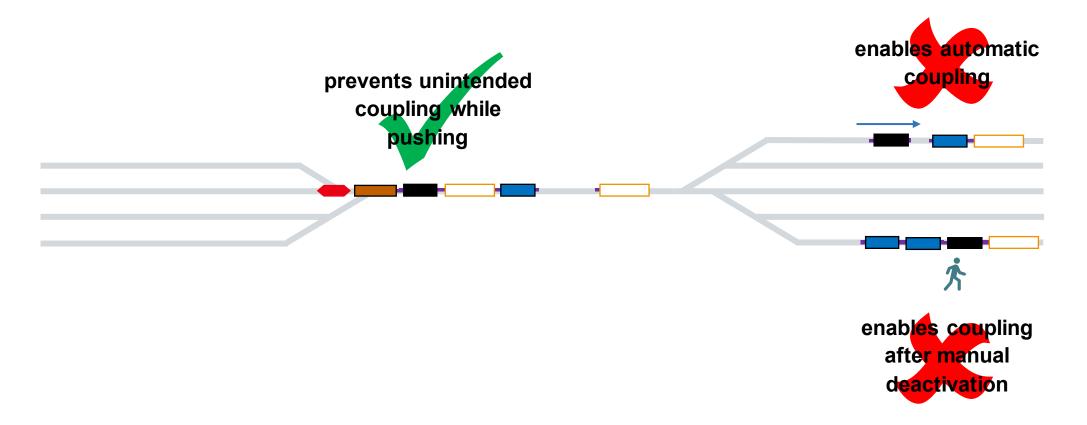
Buffer Position

\rightarrow current buffer position is no feasible solution for the whole process

\rightarrow future solution should switch to "ready to couple" when wagon starts rolling down the hump

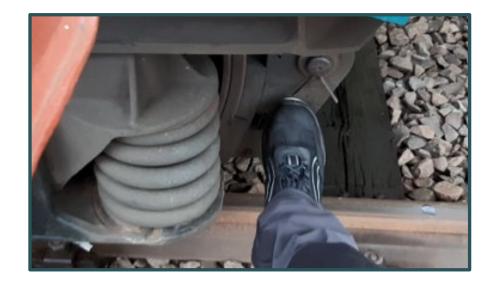
- Closing the DAC's pneumatic valves during uncoupling leads to a loss of air when the brake pipe is not vented before
- The pressure change in the brake is large enough for some distributor valves to apply the brakes
- Uncoupled wagons remain braked; their brakes must be manually released

\rightarrow Therefore, hump operation with unvented brake pipes is not feasible

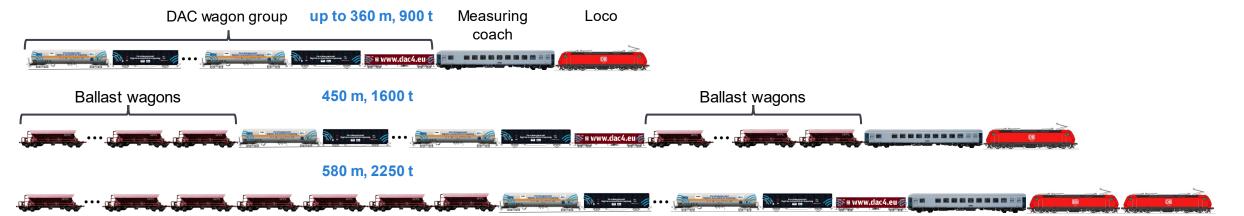
- More than 10.000 km of train runs
- Different train configurations
- Various topologies, including very steep lines with narrow curves (e.g. Gotthard line)

- \rightarrow No issues during train runs
- \rightarrow Reliable mechanical and pneumatical connection
- \rightarrow Results for electrical connections will be presented in the following (e.g., special communication tests in CZ)

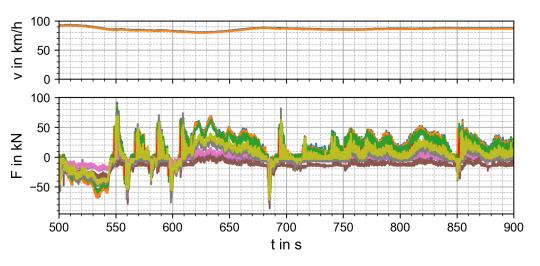
Train running at approx. constant speed

- Significant train dynamics
- Probable cause: play in DAC stabilisation joints
- Not directly critical but effects (especially for longer trains) should be checked
- \rightarrow Further investigations are currently being carried out
