## DAC4EU Data Communication Tests

Roland Hess, OWITA GmbH

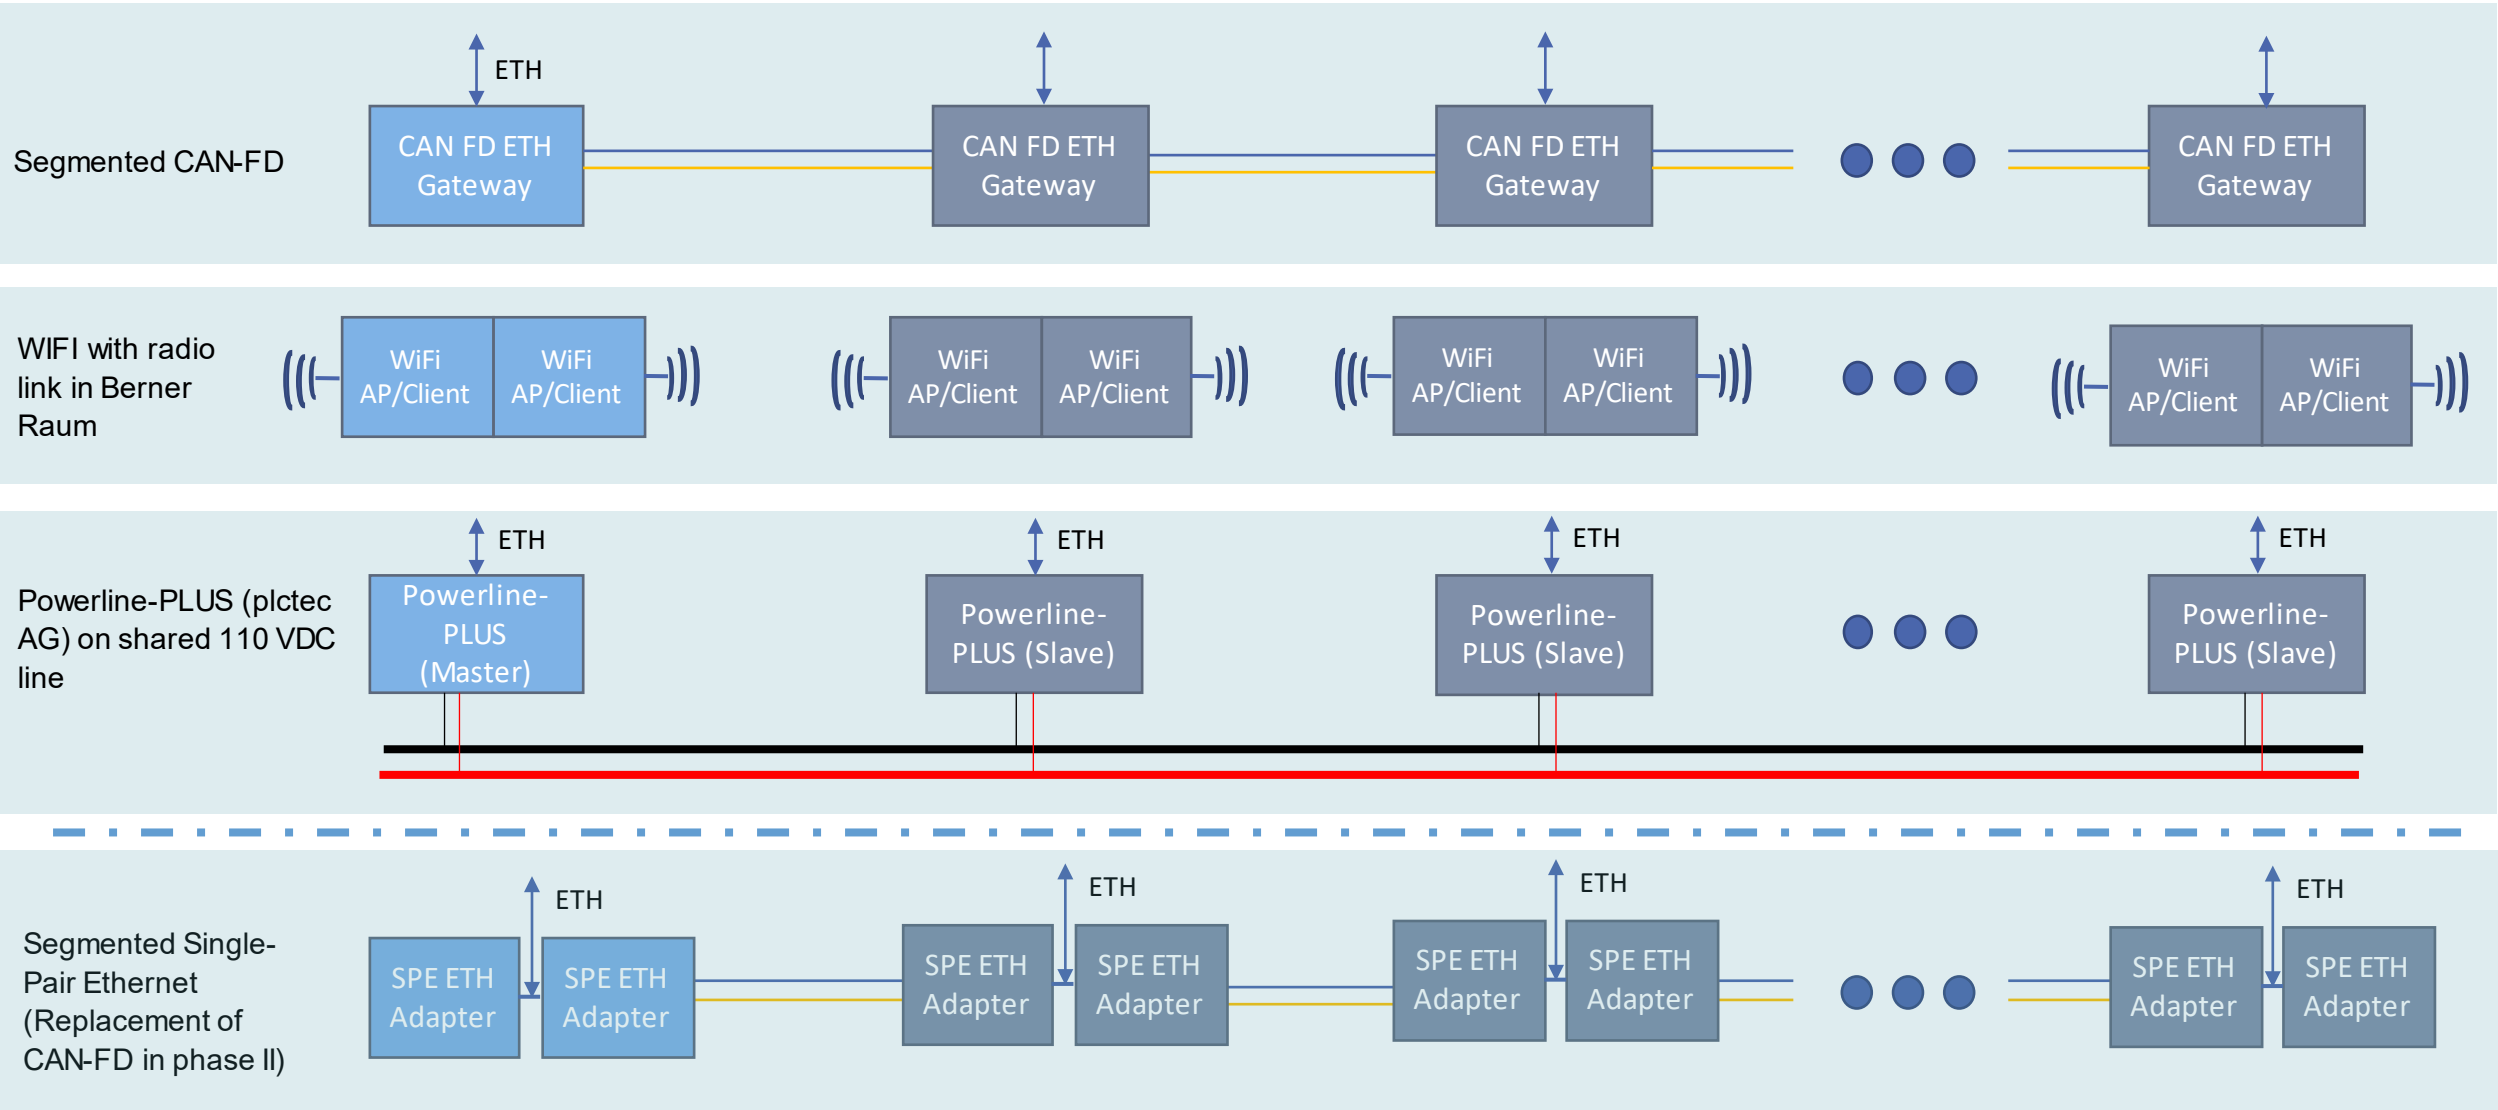
## Tested Communication Concepts

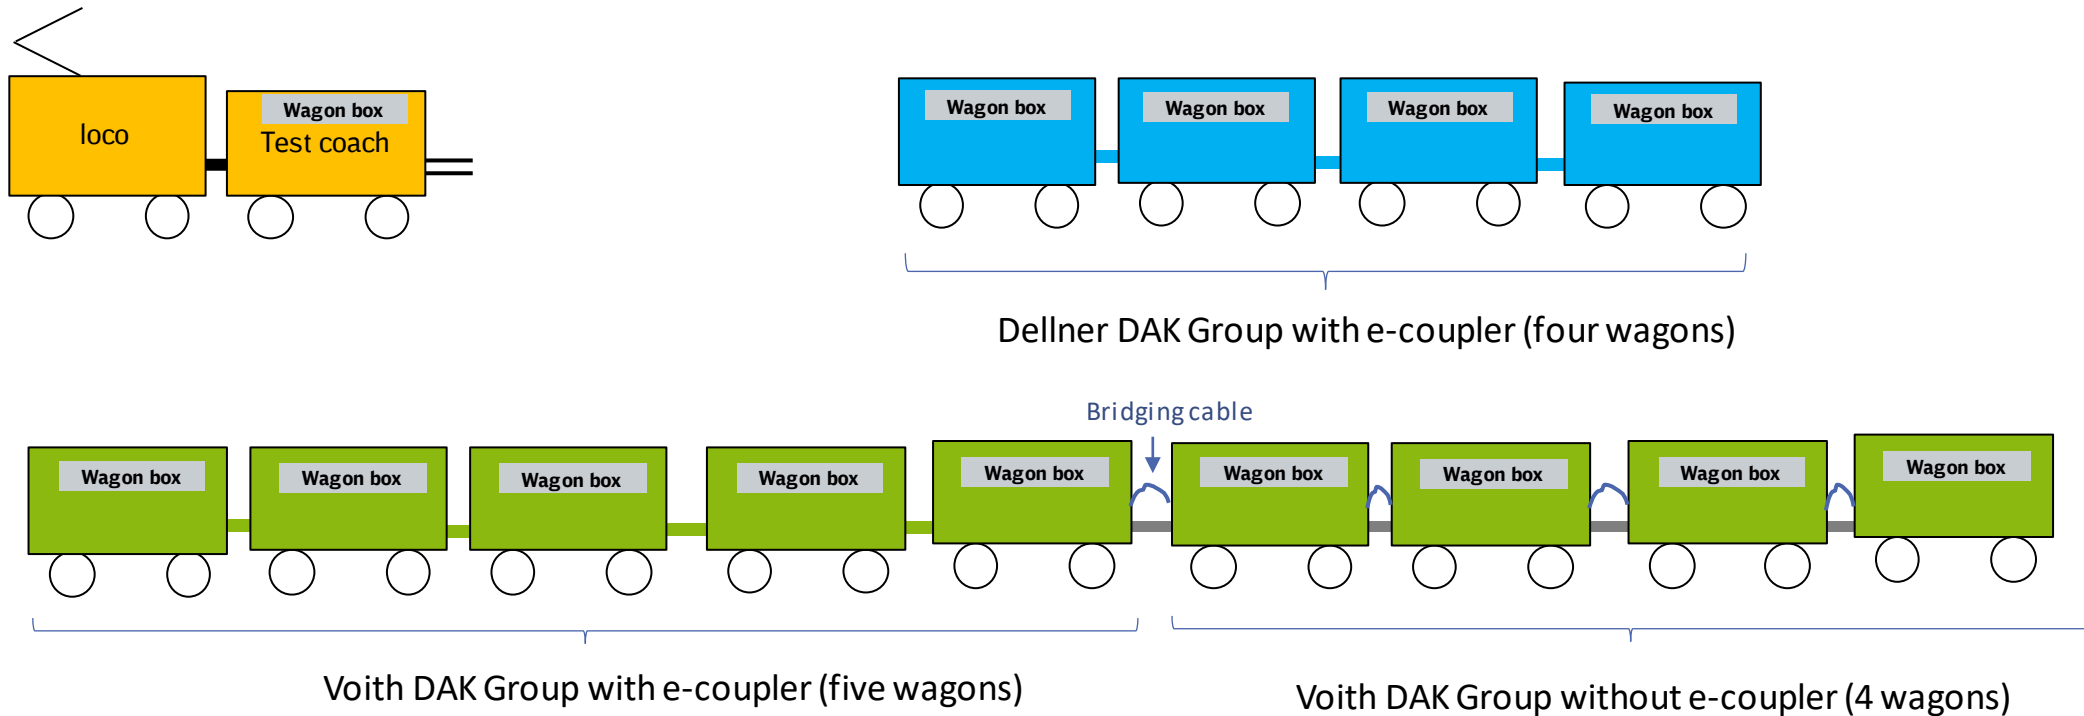
## Test Setup in Phase IIa with 13 Wagons

- Only changes of the position of the wagon groups between tests
- No changes inside wagon groups possible => Couplers always connected to the same opposite coupler partner

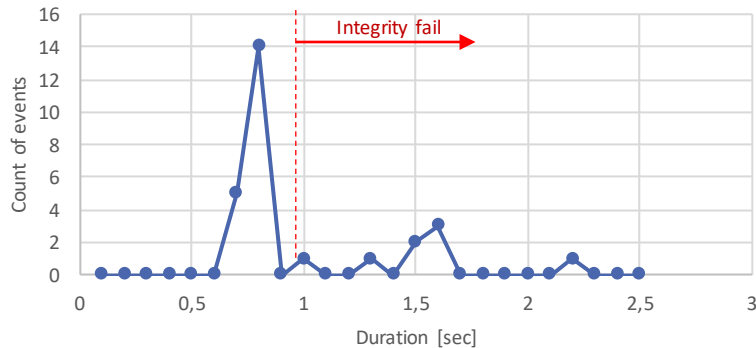
Histogram of communication losses and duration T7

→ **Massive communication problems started** at tests with **T7**

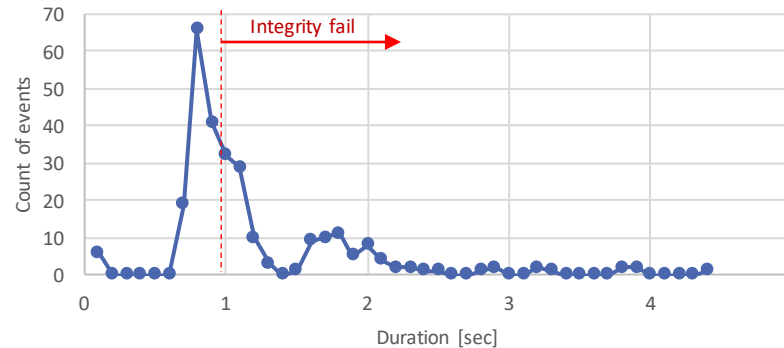
Histogram of communication losses and duration T8

→ With test T8 a new function was integrated to detect the point of failures

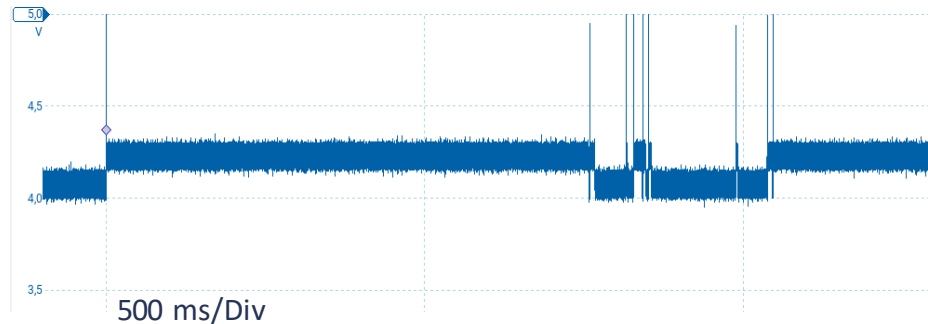
### Expected result:

Measurement idea: Monitoring of all coupler connections on communication line (with location tracking of the interruption)

- Second two wire line connected in the wagon boxes to get connected line through the train
- Resistor installed in each wagon between the two wires
- Measurement of the current with an oscilloscope (by shunt resistor) should show the length and location of interruptions

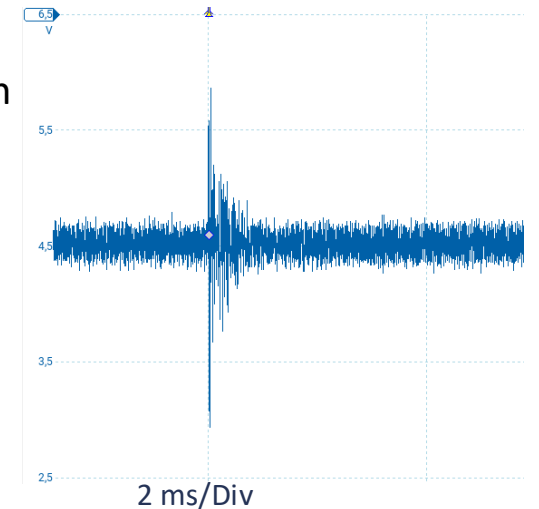
- **No (long) interruption** on communication pins could be seen
- Sporadic **distorsions** on the line, but very **short pulses**
- Distorsions can often be seen after **train vibrations**, but also in standstill
- Assumption: Crosstalk from the powerline to the data bus line at specific wagons
