# DAC Test Train in Poland 2022

DAC4EU Frankfurt 30.11.2022

## DAC Test Train by the DAC4EU Consortium at PKP CARGO Tests in Poland:

Tests 10th -20th July 2022

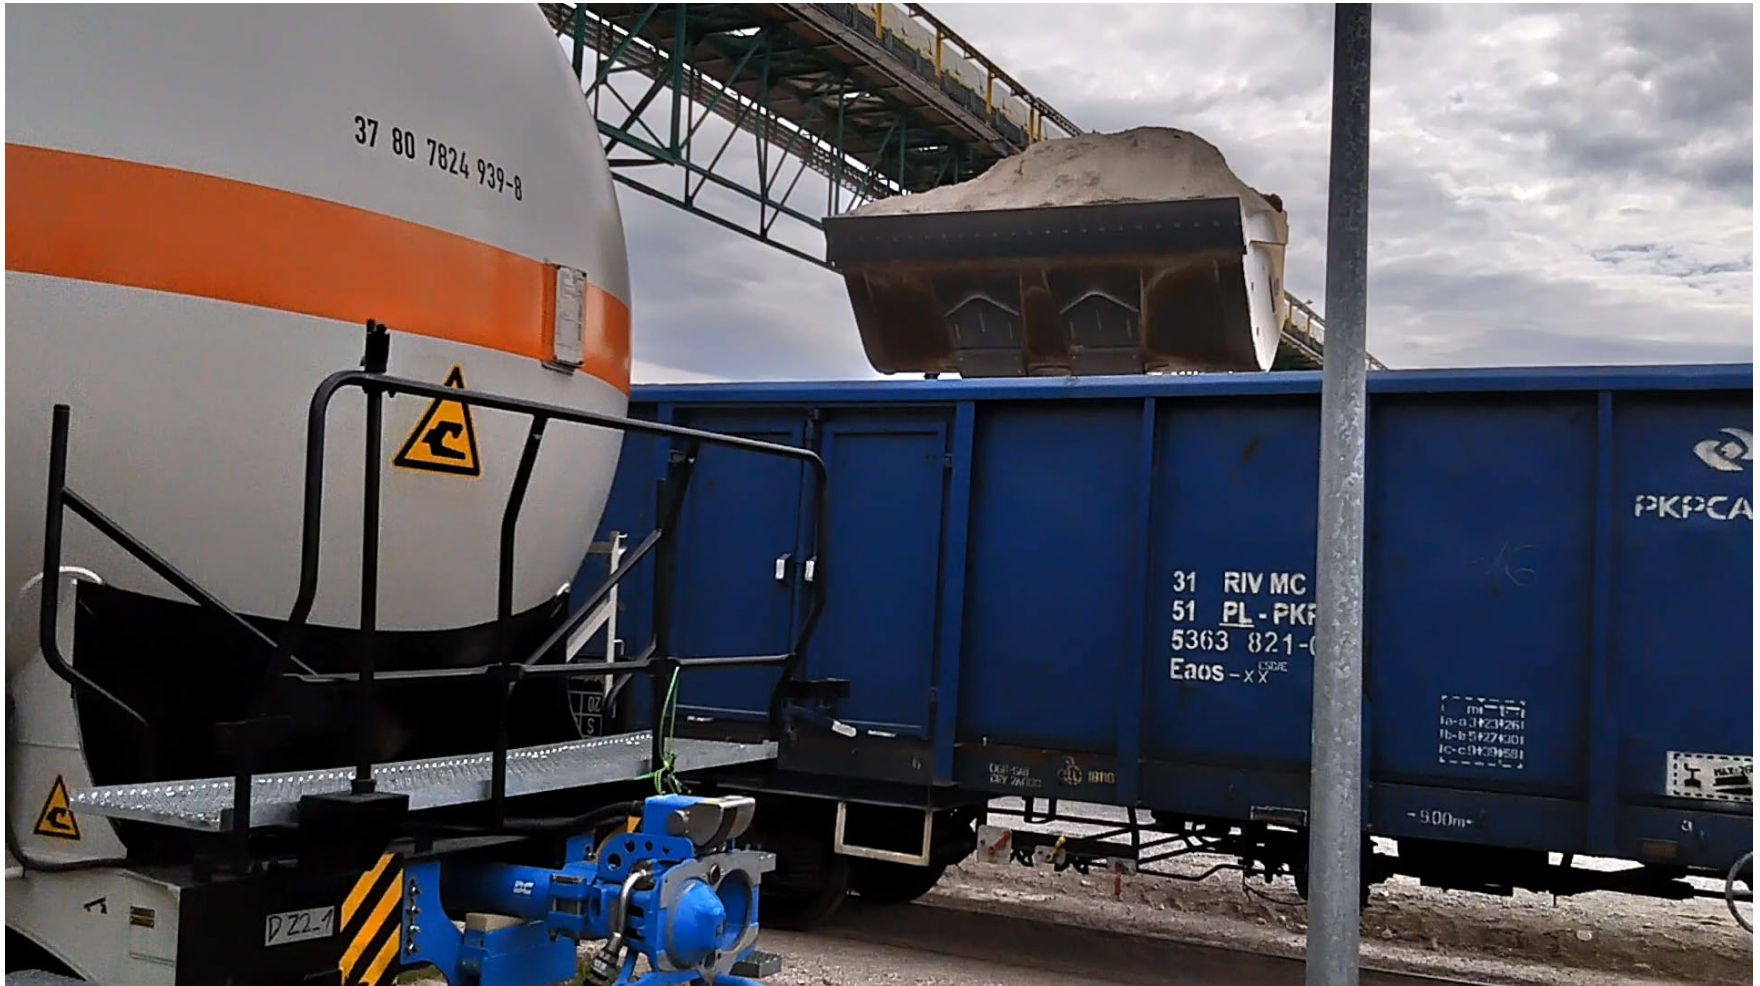
- Cement plant Lafarge

- ❑ **Visual checking of the contamination inside the open part of the brake pipe in the DAC-head showed that air was contaminated by dust and small particles of the lime stone material.**
- ❑ **The small particles of the lime stone material were caught by a piece of cotton cloth, which has been inserted between the air coupling heads. The amount of contaminants in the air raises serious doubts to the proper operation of the brake's pneumatic valves.**

**There may be a problem of contamination of the main brake pipe when loading / unloading loose bulk materials - further investigation needed**
